Image Corner

Image 4: Plain CT brain – 25/female

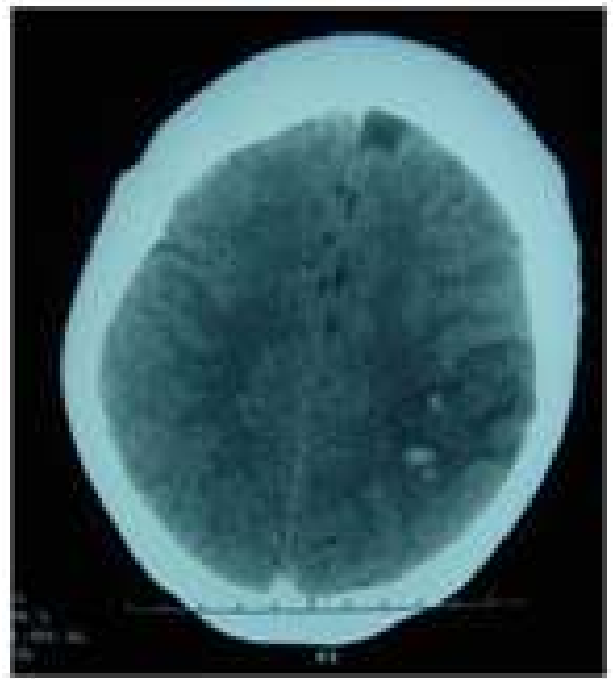
This patient has hemorrhagic foci with edema at left frontoparietal region which can be passed off as hemorrhagic contusion; however note the density of the superior sagittal sinus region which is more denser than expected. This patient has confirmed as venous sinus thrombosis and the left front parietal lobe changes are actually hemorrhagic venous infarct. Clinician and Radiologists should always look for clues that will help in reaching the appropriate diagnosis.
